**DRAFT  
ENVIRONMENTAL PRIORITIES INITIATIVE  
PRELIMINARY ASSESSMENT  
VOLUME I**

**SKF INDUSTRIES, INC.  
2320 MARCONI AVENUE  
ST. LOUIS, MISSOURI  
EPA ID #MOT300010345**

**JACOBS ENGINEERING GROUP INC.  
10901 W. 84TH TERRACE, SUITE 210  
LENEXA, KANSAS 66214**

**APRIL 13, 1992**

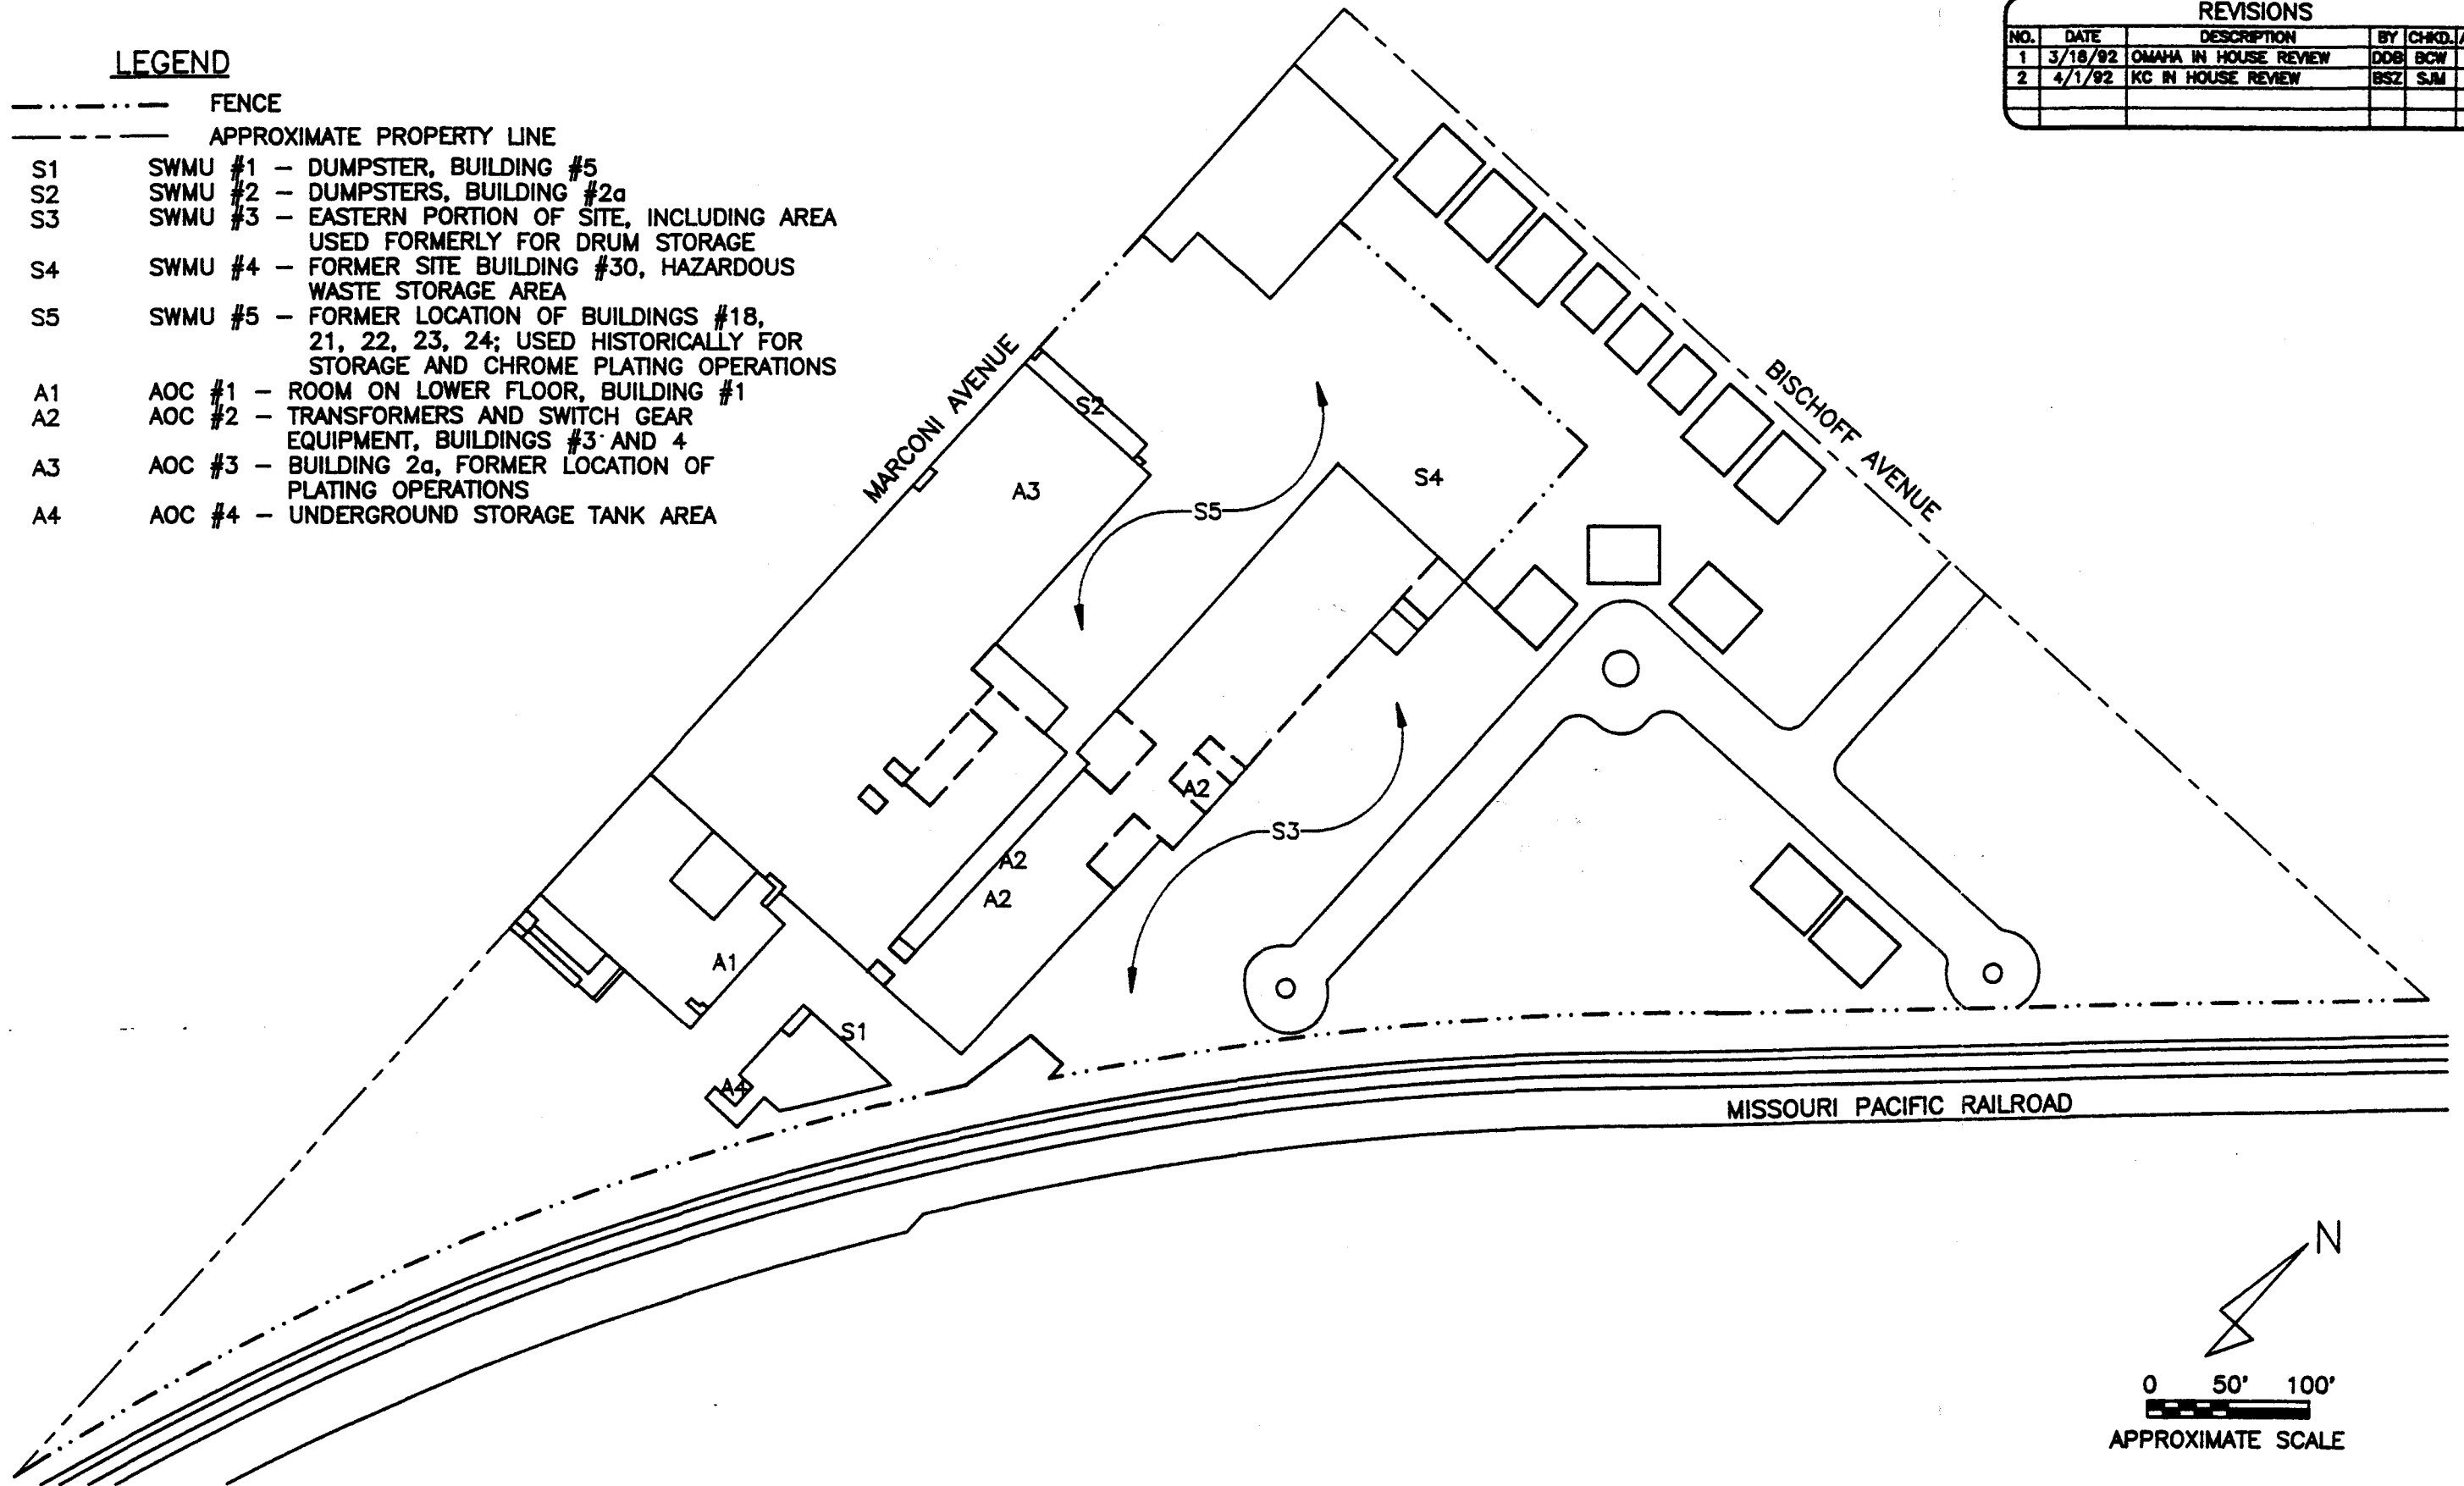
## SWMU AND AOC LOCATIONS

As a result of the VSI, five Solid Waste Management Units (SWMUs) and four Areas of Concern (AOC) were identified at the site. The SWMUs include a refuse dumpster at Building No. 5; two dumpsters at Building No. 2A; the area east of Building Nos. 4 and 25 where a former release of kerosene occurred, facility buildings had been demolished, and where former storage areas were located; the former location of Building No. 30 used formerly for storage of hazardous waste; and the former location of Building Nos. 18, 22, 21, 23, and 24, used historically for storage and chrome plating operations. AOCs identified include a room in Building No. 1 where hydrochloric acid was stored and staining of the floor was noted beneath a hot water heater/furnace; areas in Building Nos. 3 and 4 where staining was noted beneath transformers and other electrical equipment; Building No. 2A where plating operations formerly occurred; the area south of Building No. 5 where four underground storage tanks have been abandoned in place.

- S1 SWMU #1 - DUMPSTER, BUILDING #5
- S2 SWMU #2 - DUMPSTERS, BUILDING #2a
- S3 SWMU #3 - EASTERN PORTION OF SITE, INCLUDING AREA USED FORMERLY FOR DRUM STORAGE
- S4 SWMU #4 - FORMER SITE BUILDING #30, HAZARDOUS WASTE STORAGE AREA
- S5 SWMU #5 - FORMER LOCATION OF BUILDINGS #18, 21, 22, 23, 24; USED HISTORICALLY FOR STORAGE AND CHROME PLATING OPERATIONS
- A1 AOC #1 - ROOM ON LOWER FLOOR, BUILDING #1
- A2 AOC #2 - TRANSFORMERS AND SWITCH GEAR EQUIPMENT, BUILDINGS #3 AND 4
- A3 AOC #3 - BUILDING 2a, FORMER LOCATION OF PLATING OPERATIONS
- A4 AOC #4 - UNDERGROUND STORAGE TANK AREA

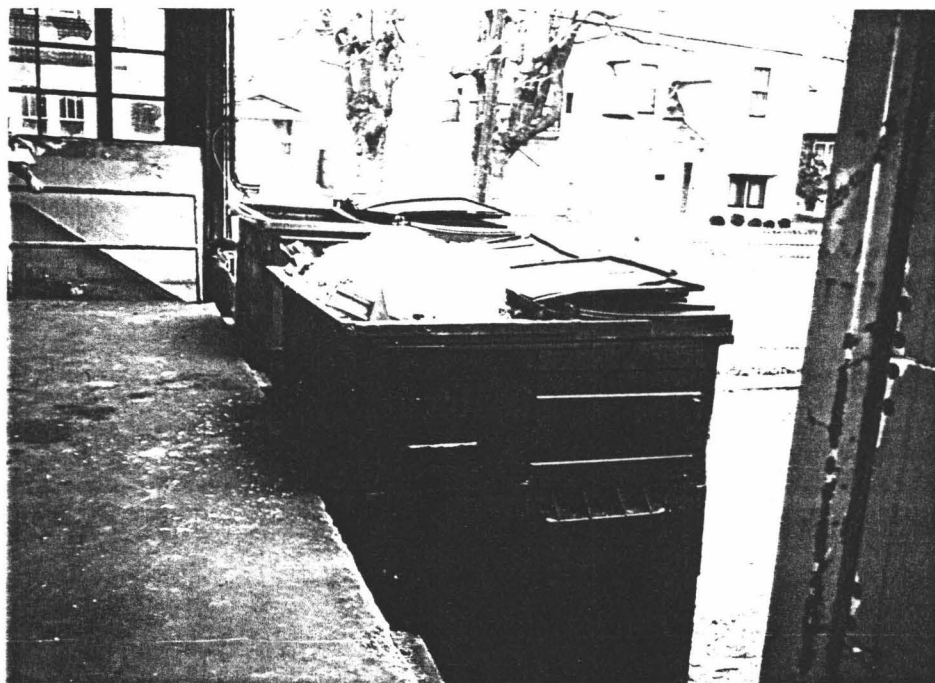
Description: Two dumpsters on north  
side of building No. 2A

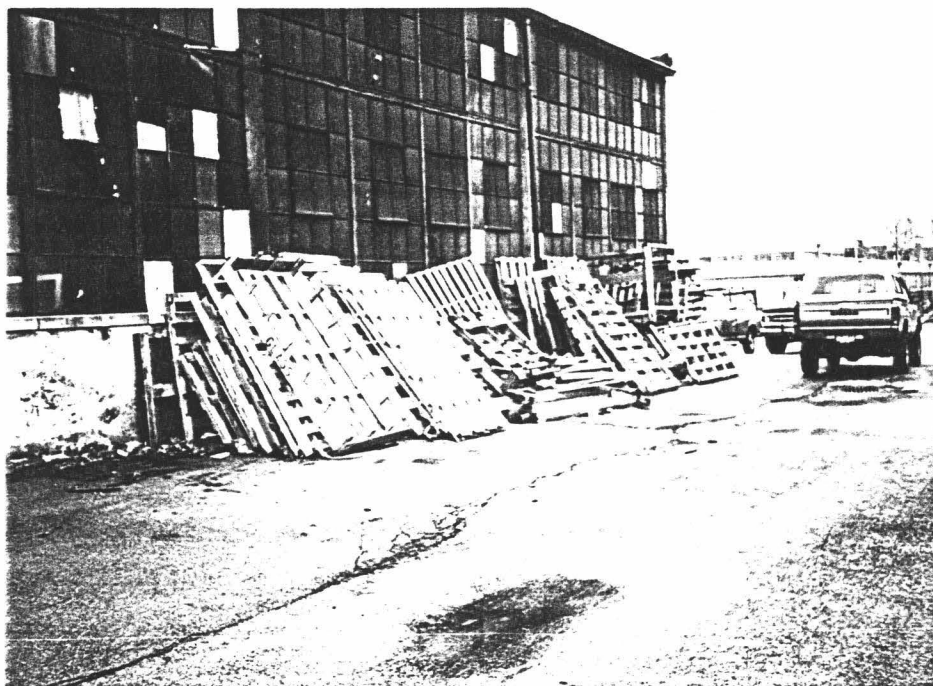
Description: Pile of pallets leaning  
against east wall of building No. 2A.  
Storm sewer  
drain is located by pickup.

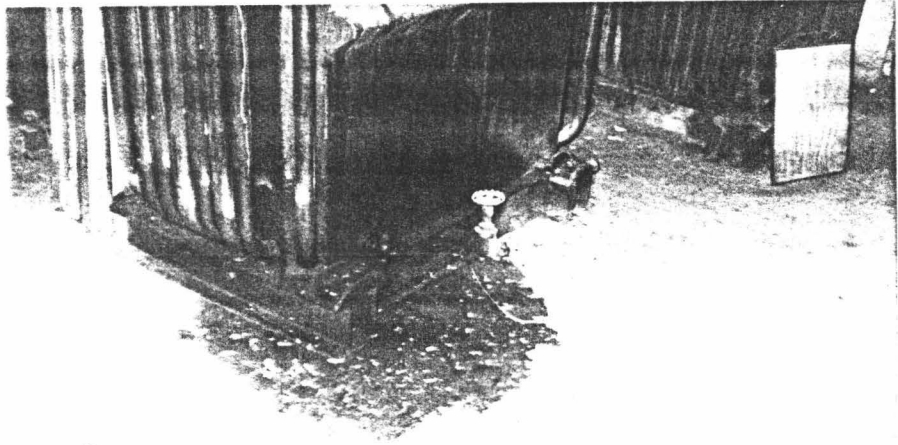
Four large transformers were found stored in a room on the west side of Building Number 4 and oil was observed on the floor beneath them. The transformers were not labeled as to their PCB content. Another room containing electrical equipment was found on the east side of Building Number 4. Four large transformers, three switching boxes, a capacitor, a generator comprised of eight batteries and a 55-gallon drum labeled "PPE" were stored in the room. Oily stains were visible on the floor.

Description: Oily stains at base of  
transformer in east room of building  
No. 4.

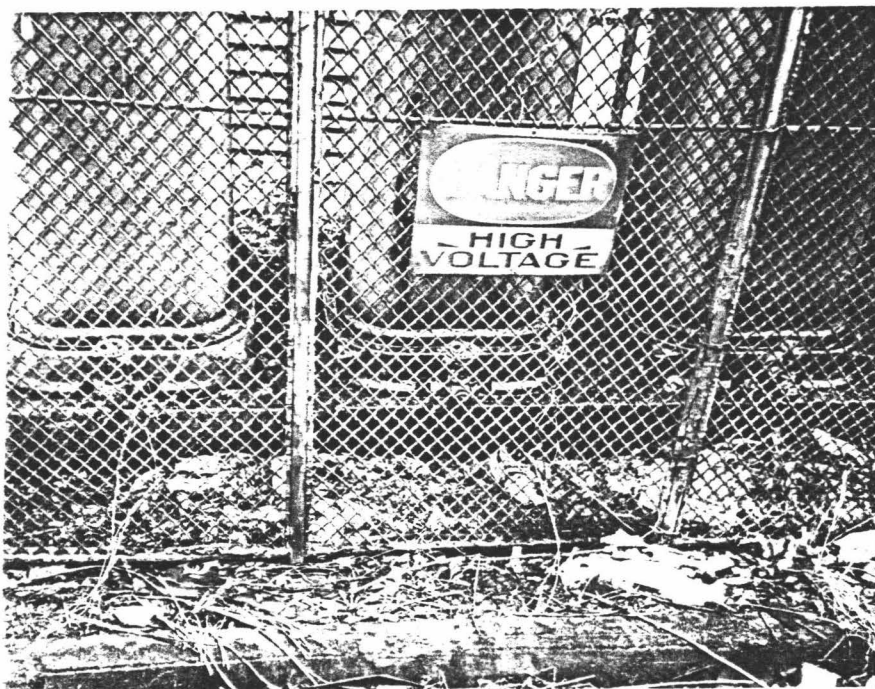
Four large transformers were also observed outside in an area between Building Numbers 3 and 4. As access was limited, observations of the area were made through an open window in Building Number 3. Stains were visible on the concrete beneath the transformers. Several empty 5-gallon buckets and other waste refuse were discarded nearby.

Description: Oily staining at base of  
transformers in alleyway between  
building Nos. 3 and 4.

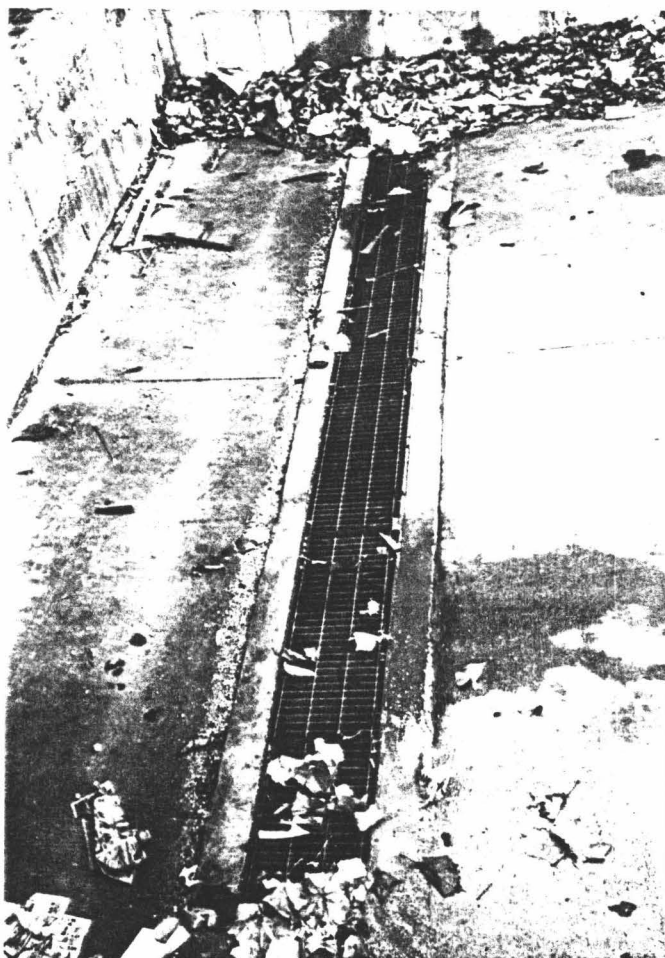
A loading dock ramp has been built adjacent to Building Number 3A. An approximate one-foot-wide storm drainage grate extends across the base of this ramp. Some oil staining was visible near this grate and at several other locations on the pavement. The oil staining appeared similar to oil staining typically left by parked automobiles. Two storm sewer drains were observed in the paved area, one east of the loading dock ramp and the other on the northeast side of Building 2A.

Description: Storm sewer grate at base  
of truck loading ramp.

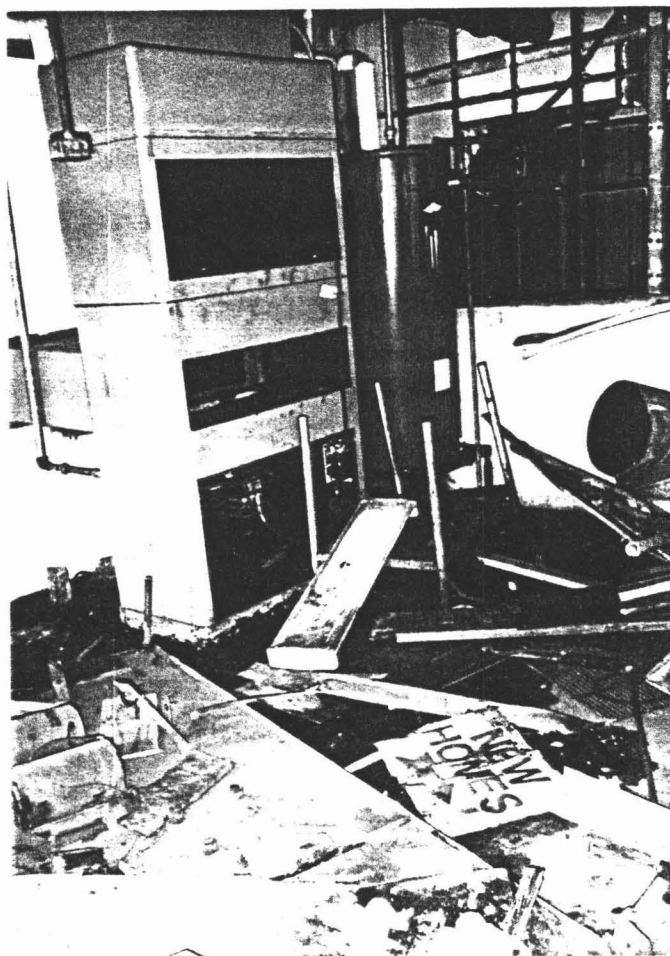
An adjacent room on the east side of the complex contained several miscellaneous items including trash, a mattress, boards, pipes, and plastic, and a partially-full 35-gallon drum labeled "hydrochloric acid", and "descaler-delimer". Staining was noted on the floor beneath a hot water heater/furnace in the room.

Description: Staining at base of furnace  
in lower level of building No. 1.
